CONNECTICUT RIVER BASIN  
SOUTHWICK, MASSACHUSETTS

CONGAMOND LAKES OUTLET  
(MIDDLE POND)  
MA 00071

PHASE I INSPECTION REPORT  
NATIONAL DAM INSPECTION PROGRAM

MARCH 1979

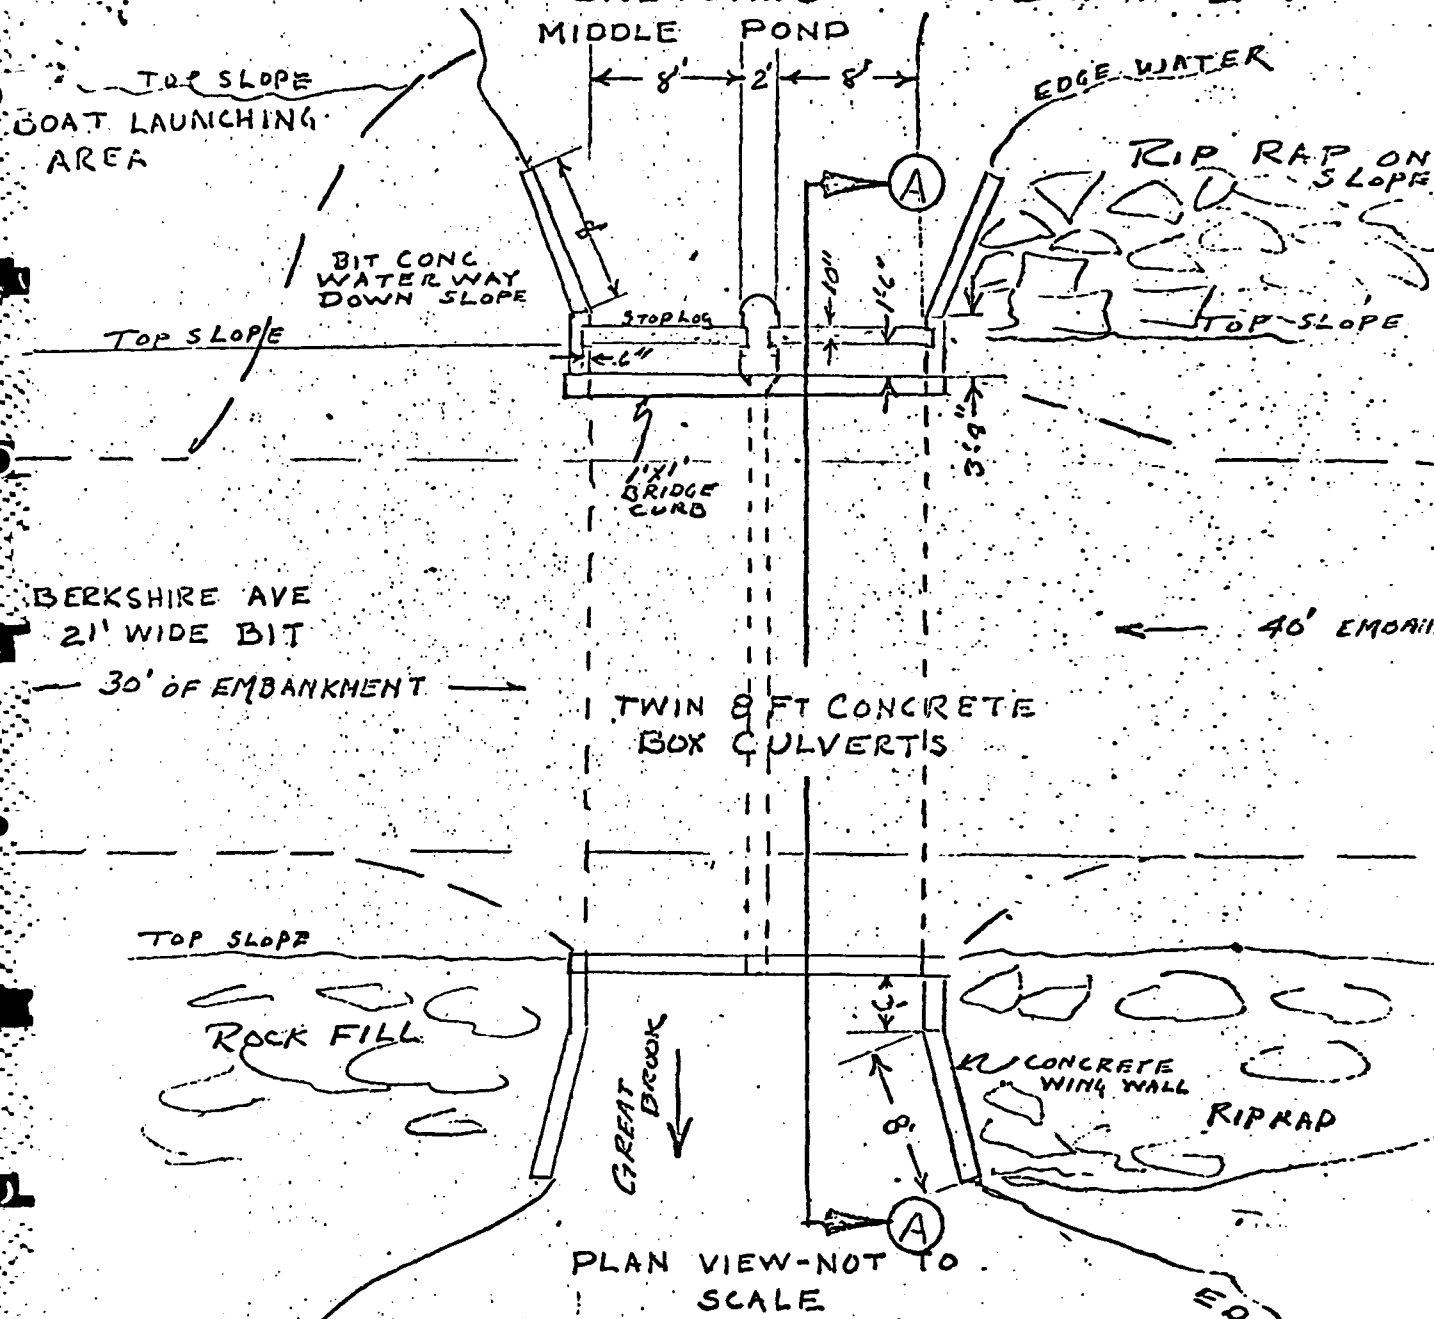
The downstream outlet channel (Great Brook) is a relatively flat marshy area having marsh vegetation. Approximately 500 feet downstream of the structure, the brook takes a sharp turn and passes under a railroad embankment, through a stone arch, shown by Photo #8. The downstream channel is shown in Photo #10.

PHOTO NO. 10 - Downstream channel taken from outlet structure.
